## **IMIDE/GRAPHITE COMPOSITE DEGRADATION MECHANISM**

Final Report  
Contract No. N00019-94-C-0207  
Contract Amount: \$58,801.30  
Contract Competitively Awarded

NAV-0207-FM-95123-934

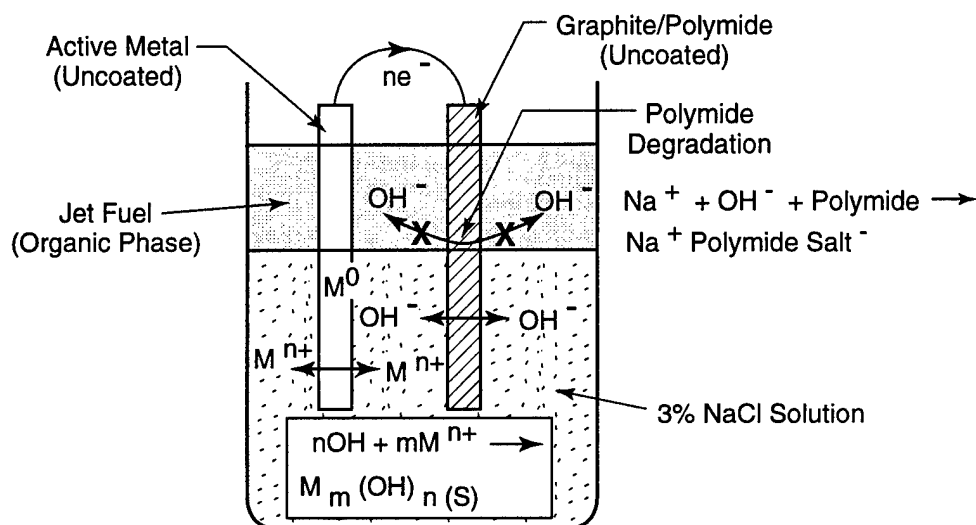
316-NAV-95123-1

In Figure 1, metal ions go into solution sending electrons to the graphite cathode. This allows  $\text{OH}^-$  ions to be generated at the graphite surfaces, in contact with the aqueous phase. The pH of the aqueous region above the interface is much higher than that of the bulk saltwater solution. This in effect served as a means of concentrating the hydroxyl ions in a confined area. This is a form of "crevice corrosion" (7). The pH in this area can be ~13, hence attack of the imide ring occurs resulting in the formation of an amide salt.

**Figure 1. Galvanic process that results in hydrolysis of an imide**

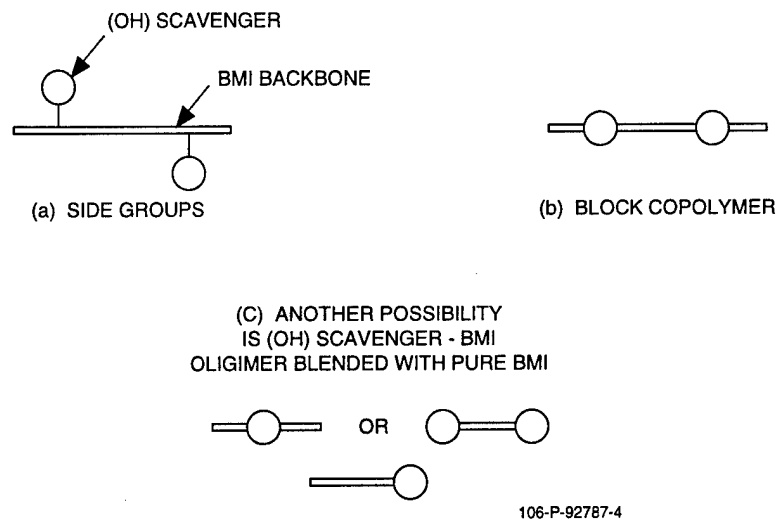
The innovation pursued in this Phase I effort for the prevention of galvanic-induced degradation is based on using a hydroxyl group scavenger within the composite. This can be accomplished by 1) incorporating the hydroxyl scavenger into the backbone of the BMI resin or 2) use as an oligomer blended with pure BMI. Figure 2 illustrates this solution.

**Figure 2.** *Use of hydroxyl group scavengers to prevent corrosive attack from occurring*

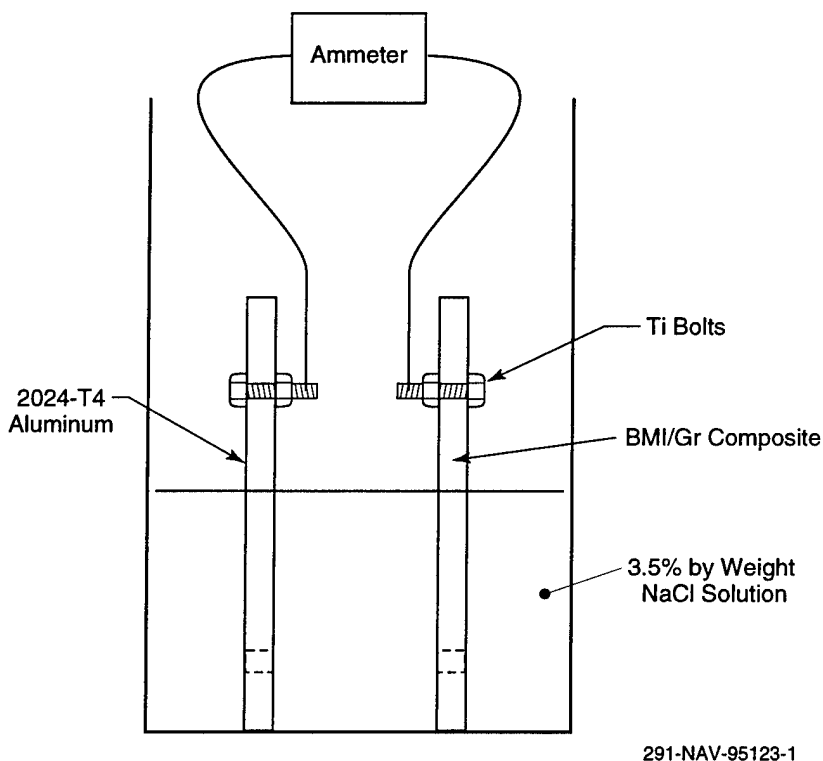
291-NAV-95123-1

**Figure 3. Experimental galvanic cell setup for monitoring corrosion rate**

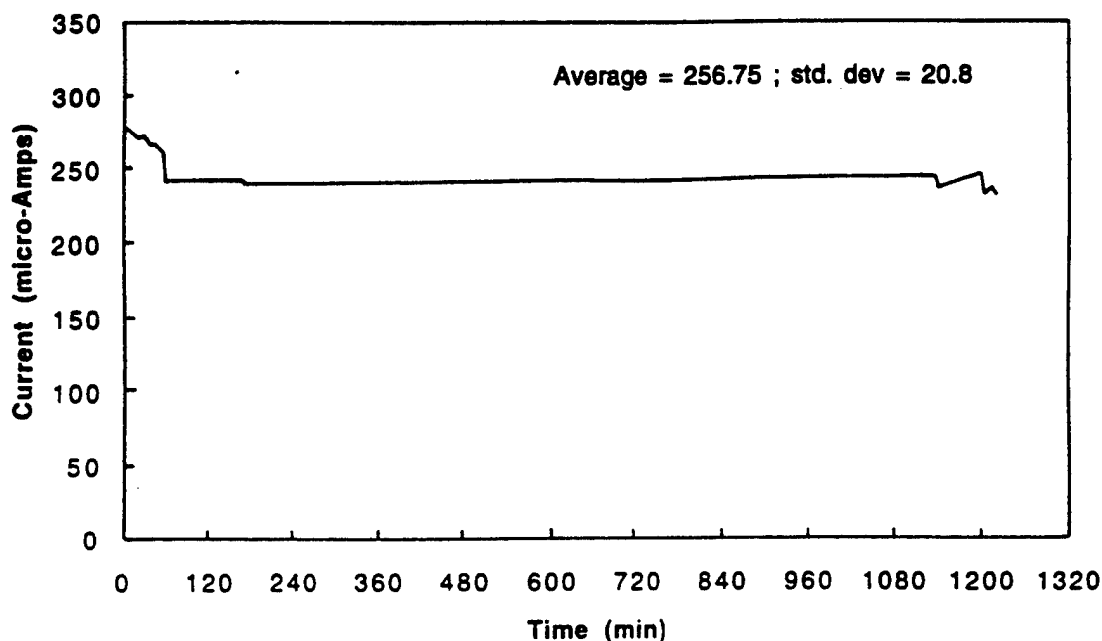
**Figure 4. Galvanic current as function of time**

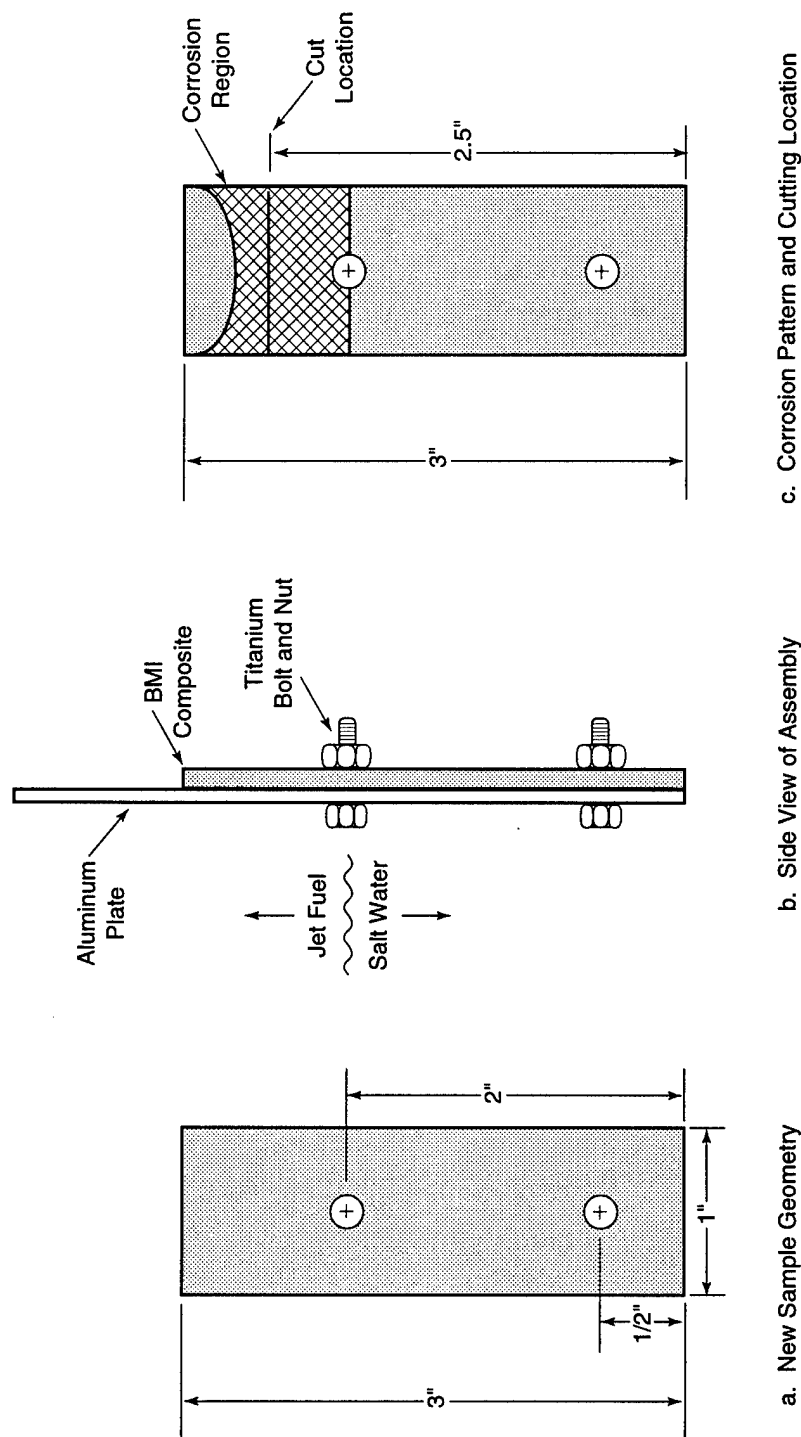
310-NAV-95123-1

**Figure 6. Composite sample for corrosion experiment**

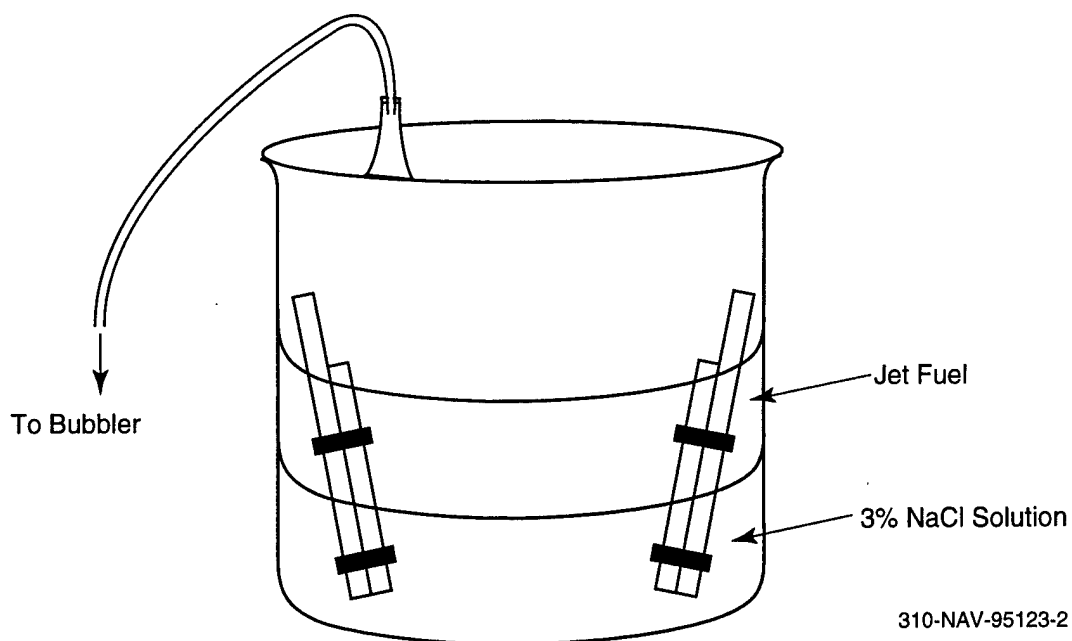
310-NAV-95123-2

**Figure 7. Corrosion bath setup**

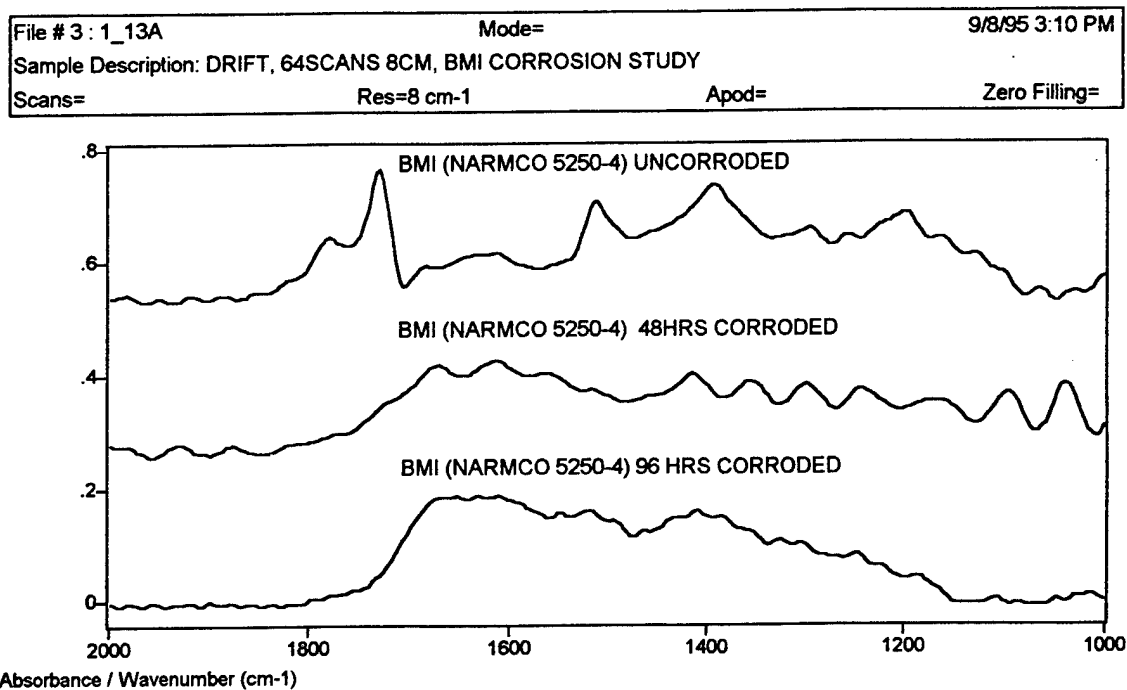
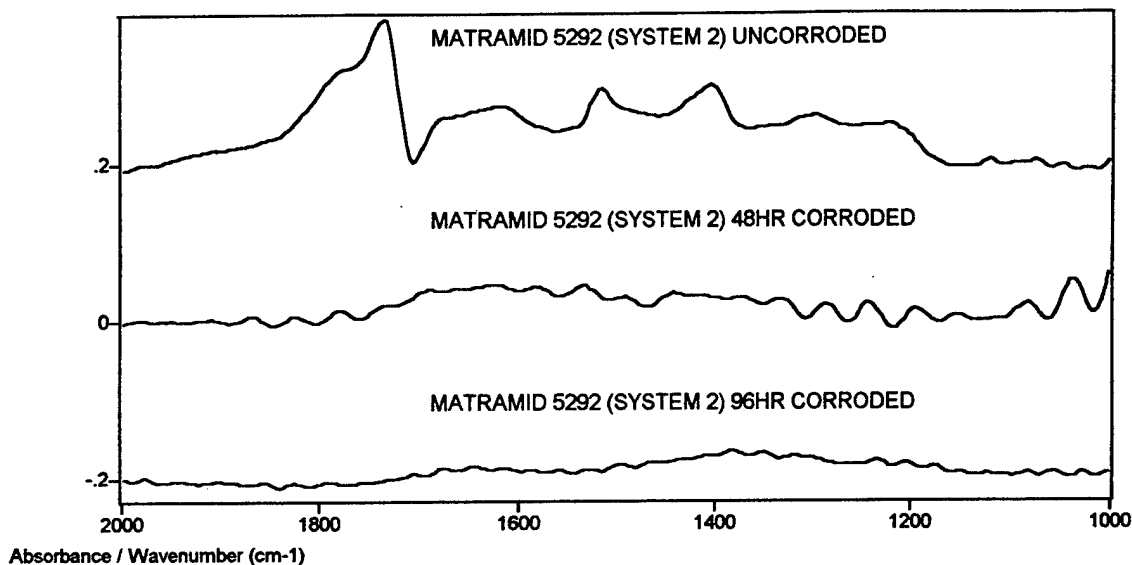
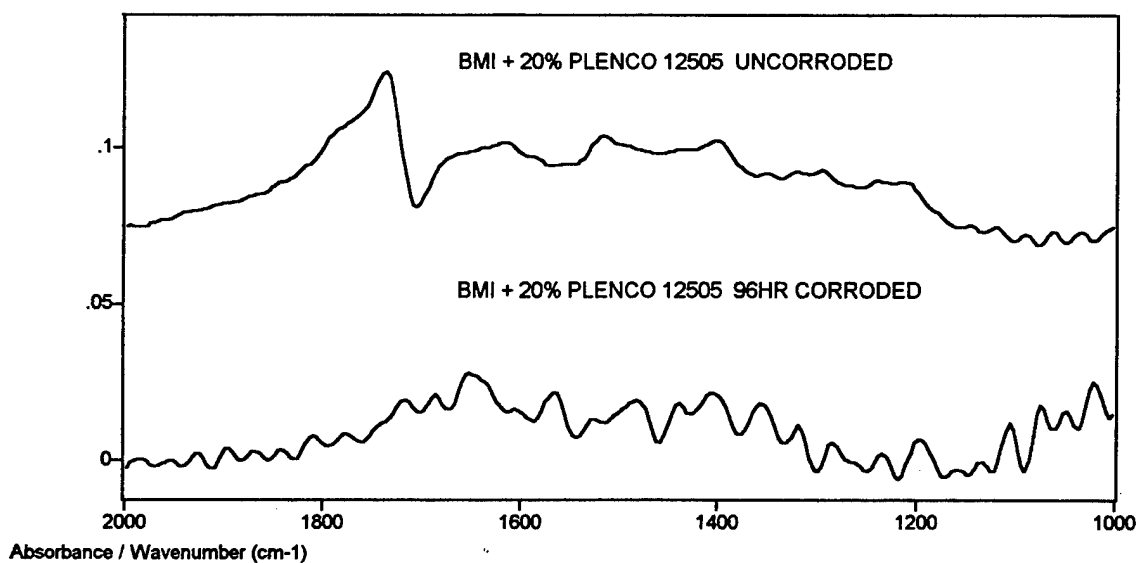
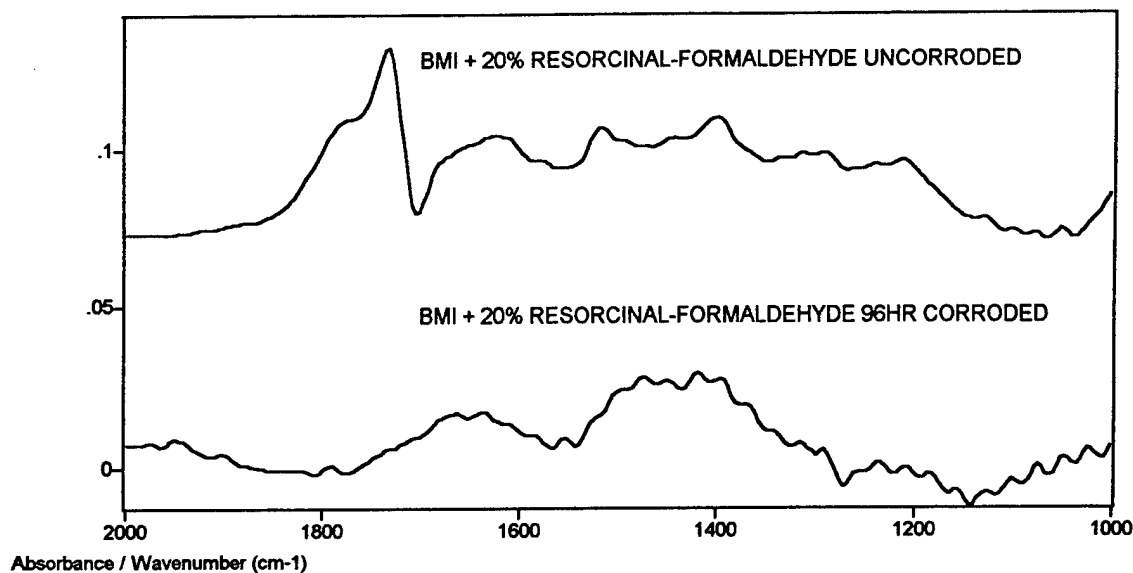
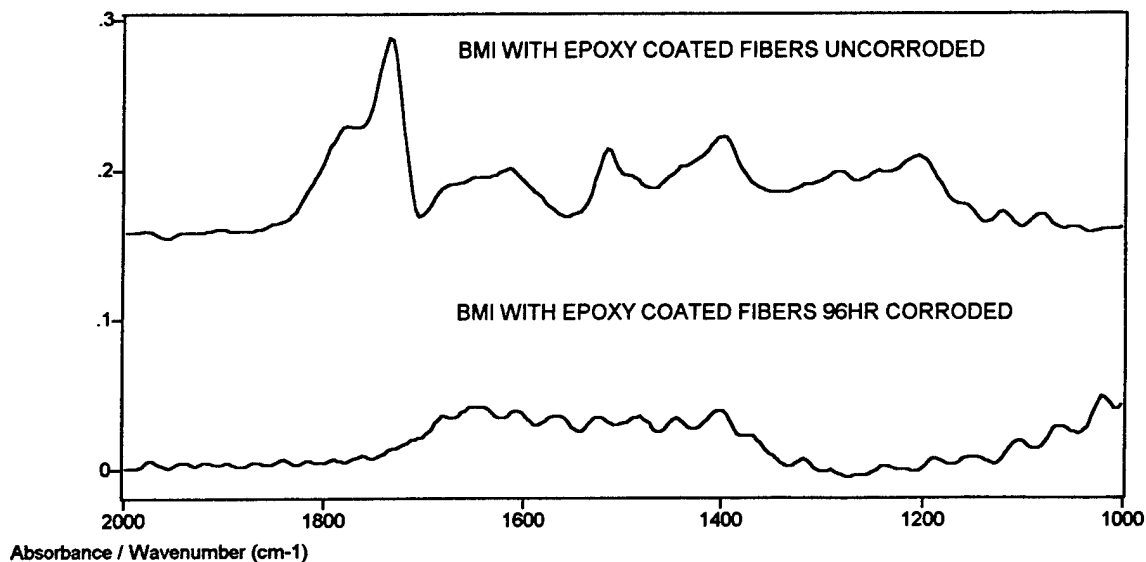
**Figure 8a. Stacked spectral plots of BMI control samples in uncorroded, 48 hr corroded, and 96 hr corroded conditions**

**Figure 8b. Stacked spectral plots of Matrimid samples in uncorroded, 48 hr corroded, and 96 hr corroded conditions**

**Figure 8c. Stacked spectral plots of Plenco 12505 modified samples in uncorroded and 96 hr corroded conditions**

**Figure 8d. Stacked spectral plots of Penacolite B-1A modified samples in uncorroded and 96 hr corroded conditions**

**Figure 8e. Stacked spectral plots of epoxy coated fiber samples in uncorroded and 96 hr corroded conditions**

The spectra from all samples are very similar. All exhibit decay of the imide ring, which absorbs at  $1733\text{ cm}^{-1}$ , and formation of the carboxylic acid moiety at  $1650\text{ cm}^{-1}$ . These features indicate similar degradation mechanisms in all samples. From these results, it does not appear that the scavengers had any effect on the degradation mechanism.

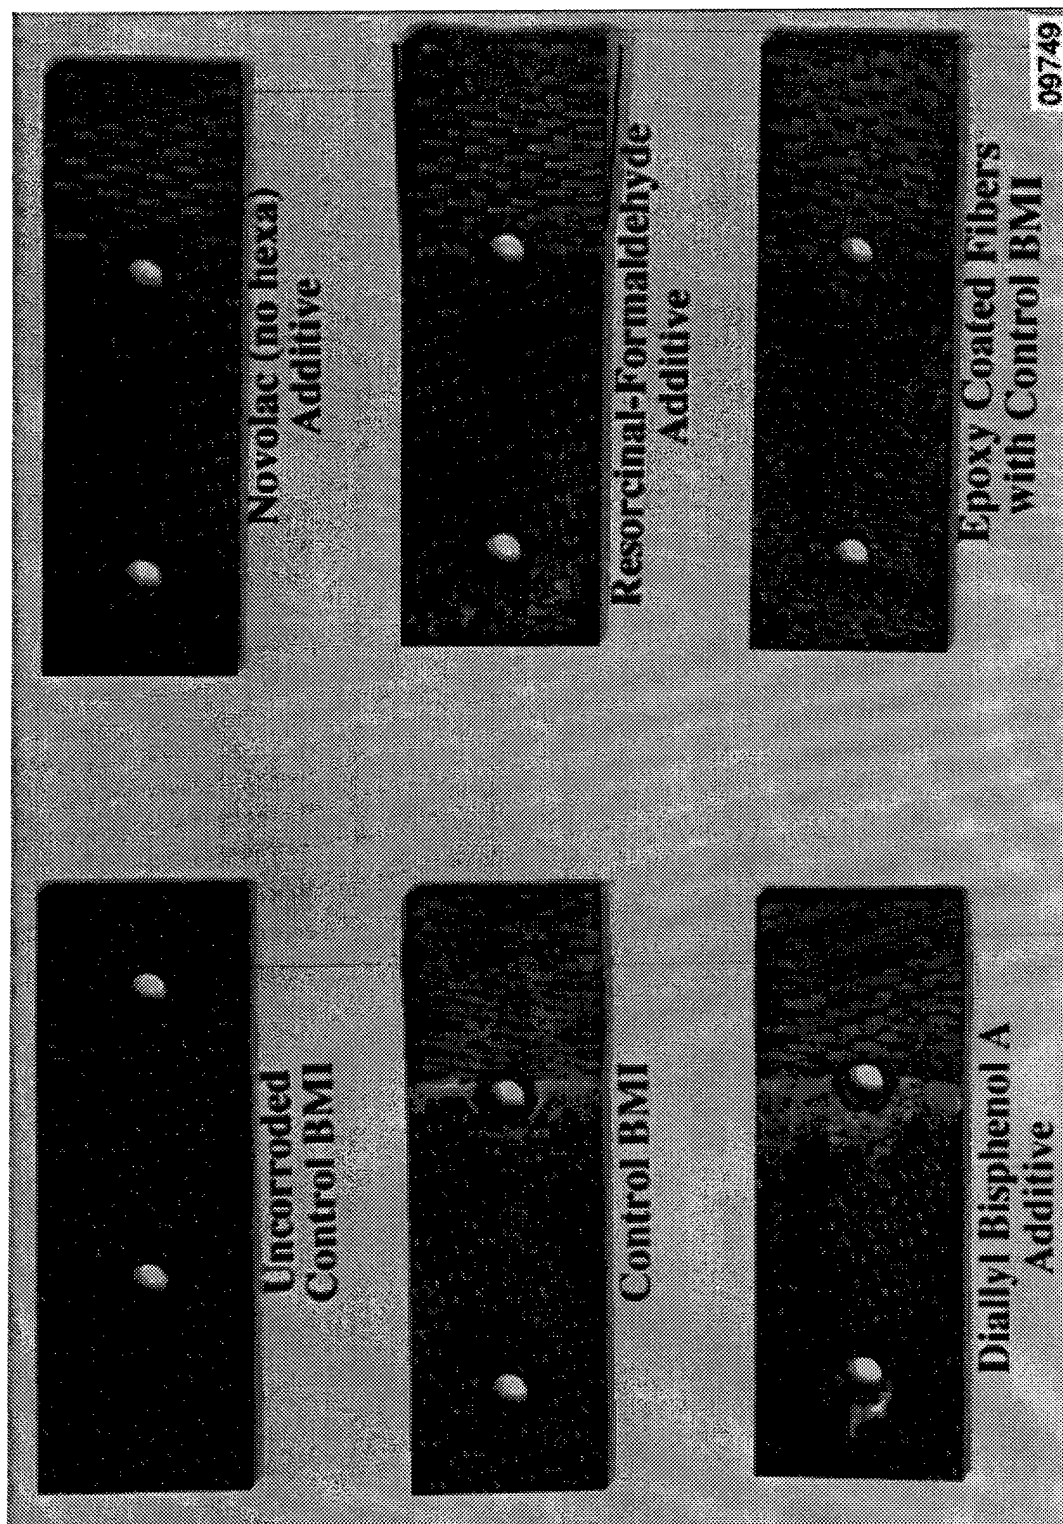
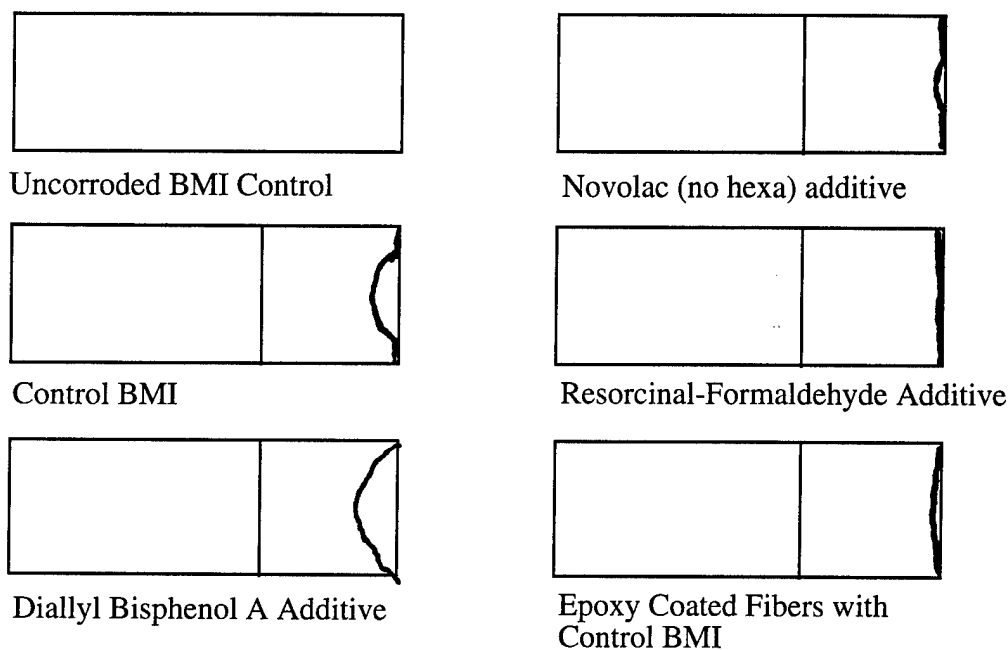
**Figure 9a.** Photos of uncorroded control sample and all sample types corroded for 96 hr at 80°C

**Figure 9b. Illustration of the size of the corroded region for the samples in Figure 9a**

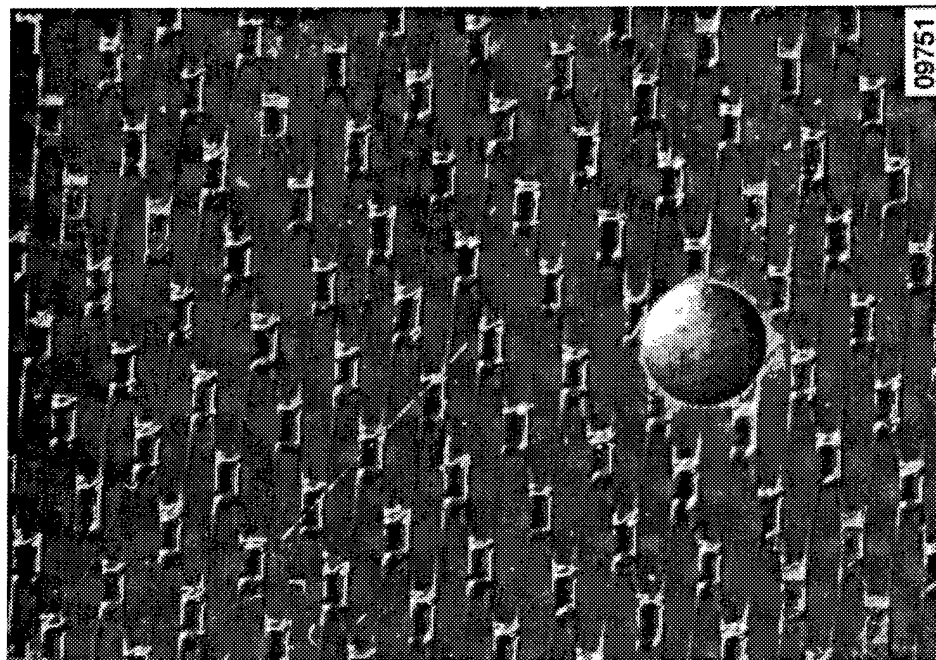
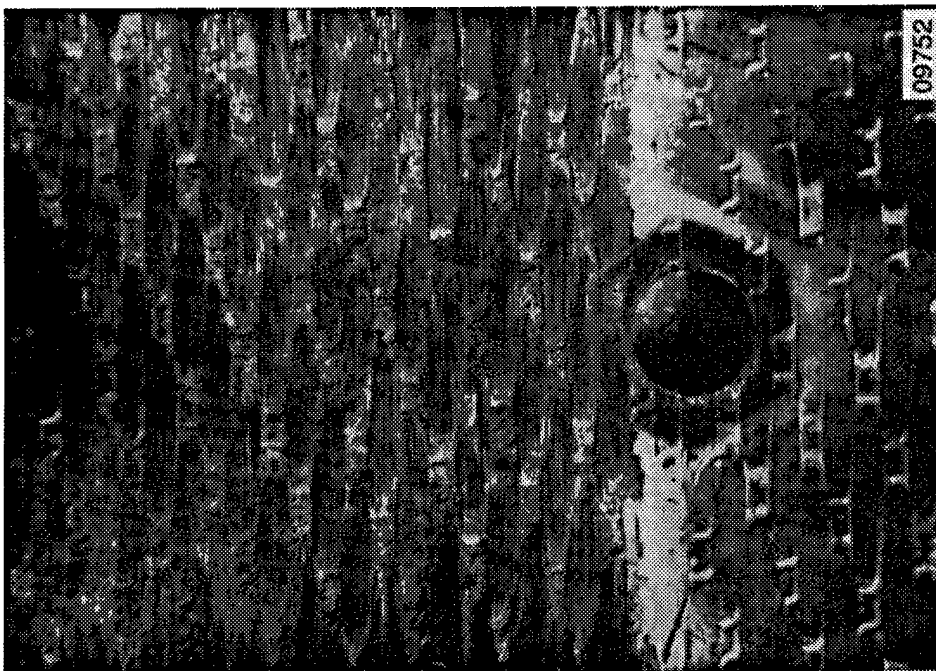
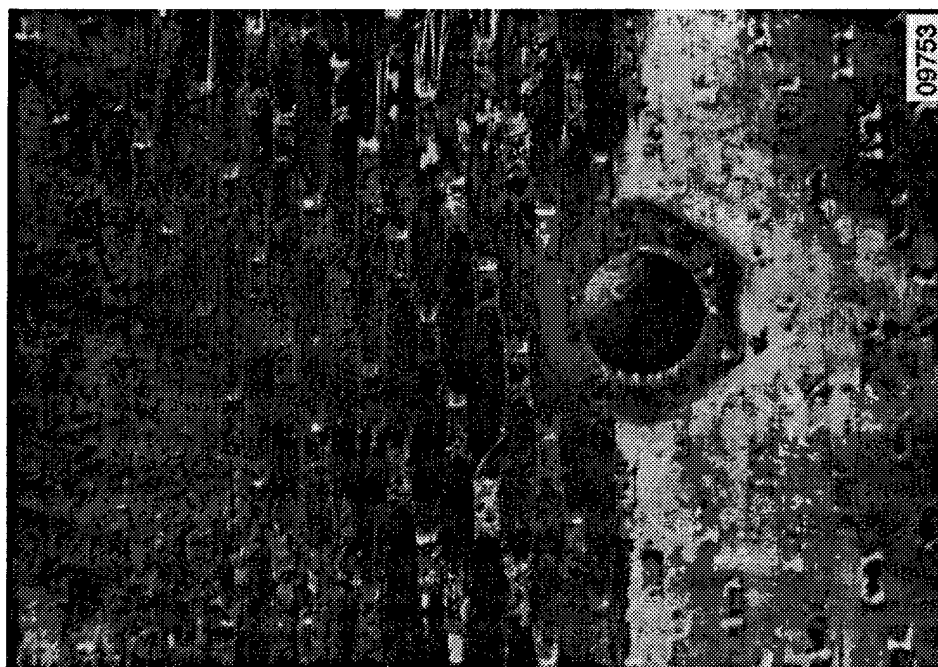
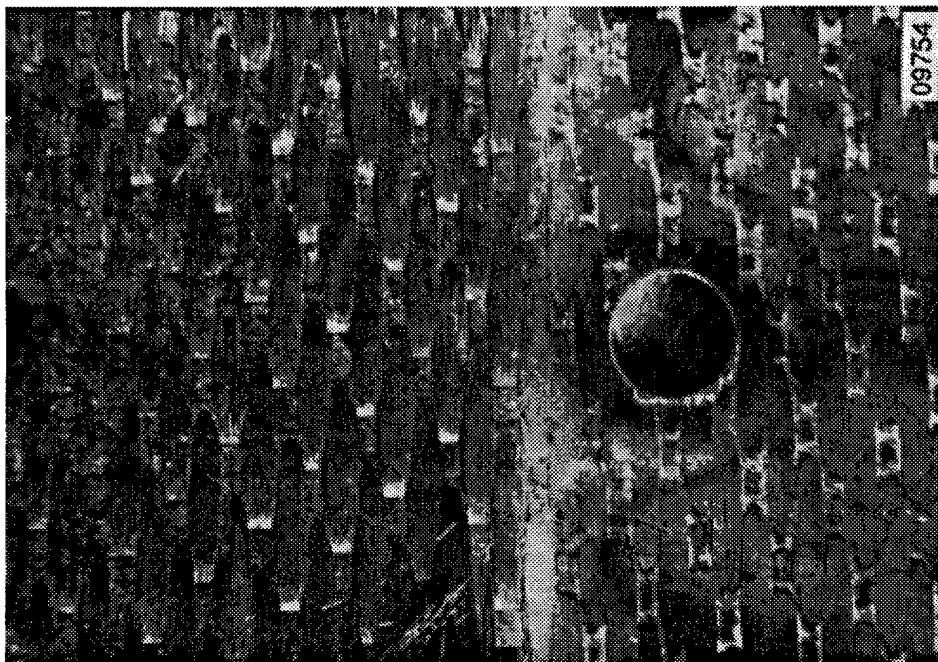
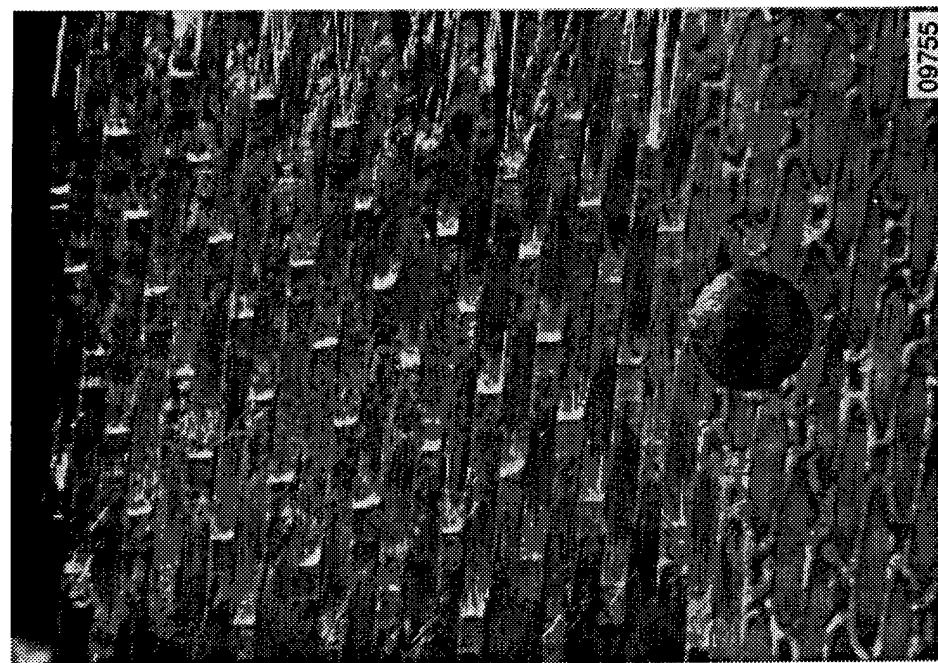
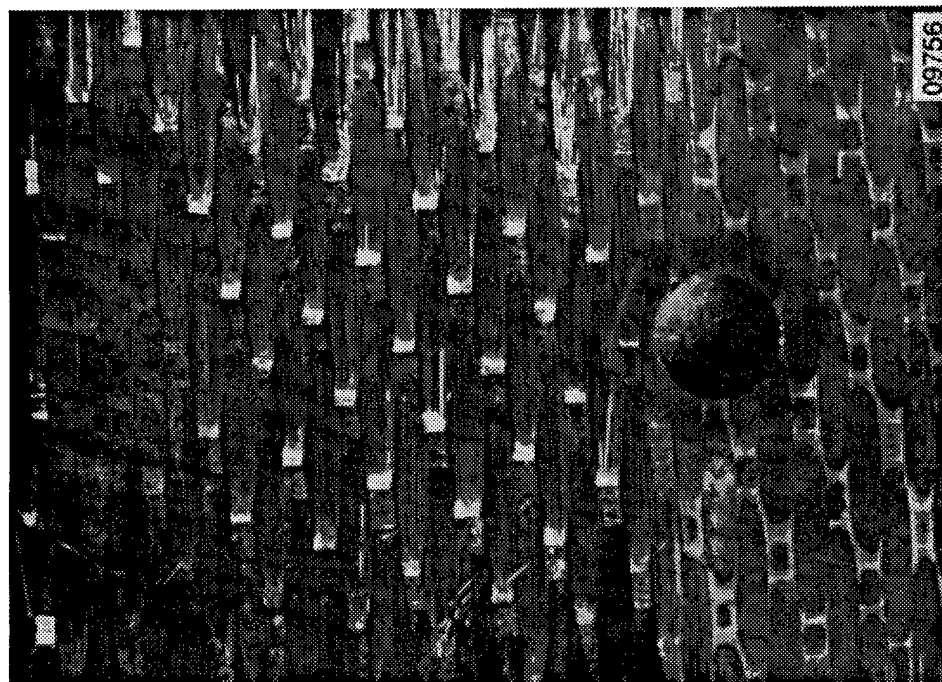
**Figure 10a.** Close-up view of an uncorroded BMI control sample

**Figure 10b.** Close-up view of a BMI control sample corroded 96 hr at 80°C

**Figure 10c.** Close-up view of a Matrimid 5292 sample corroded 96 hr at 80°C

**Figure 10d.** Close-up view of a Plenco 12505 modified sample corroded 96 hr at 80°C

**Figure 10e.** Close-up view of a Penacolite B-1A modified sample corroded 96 hr at 80°C

**Figure 10f.** Close-up view of an epoxy coated fiber sample corroded 96 hr at 80°C

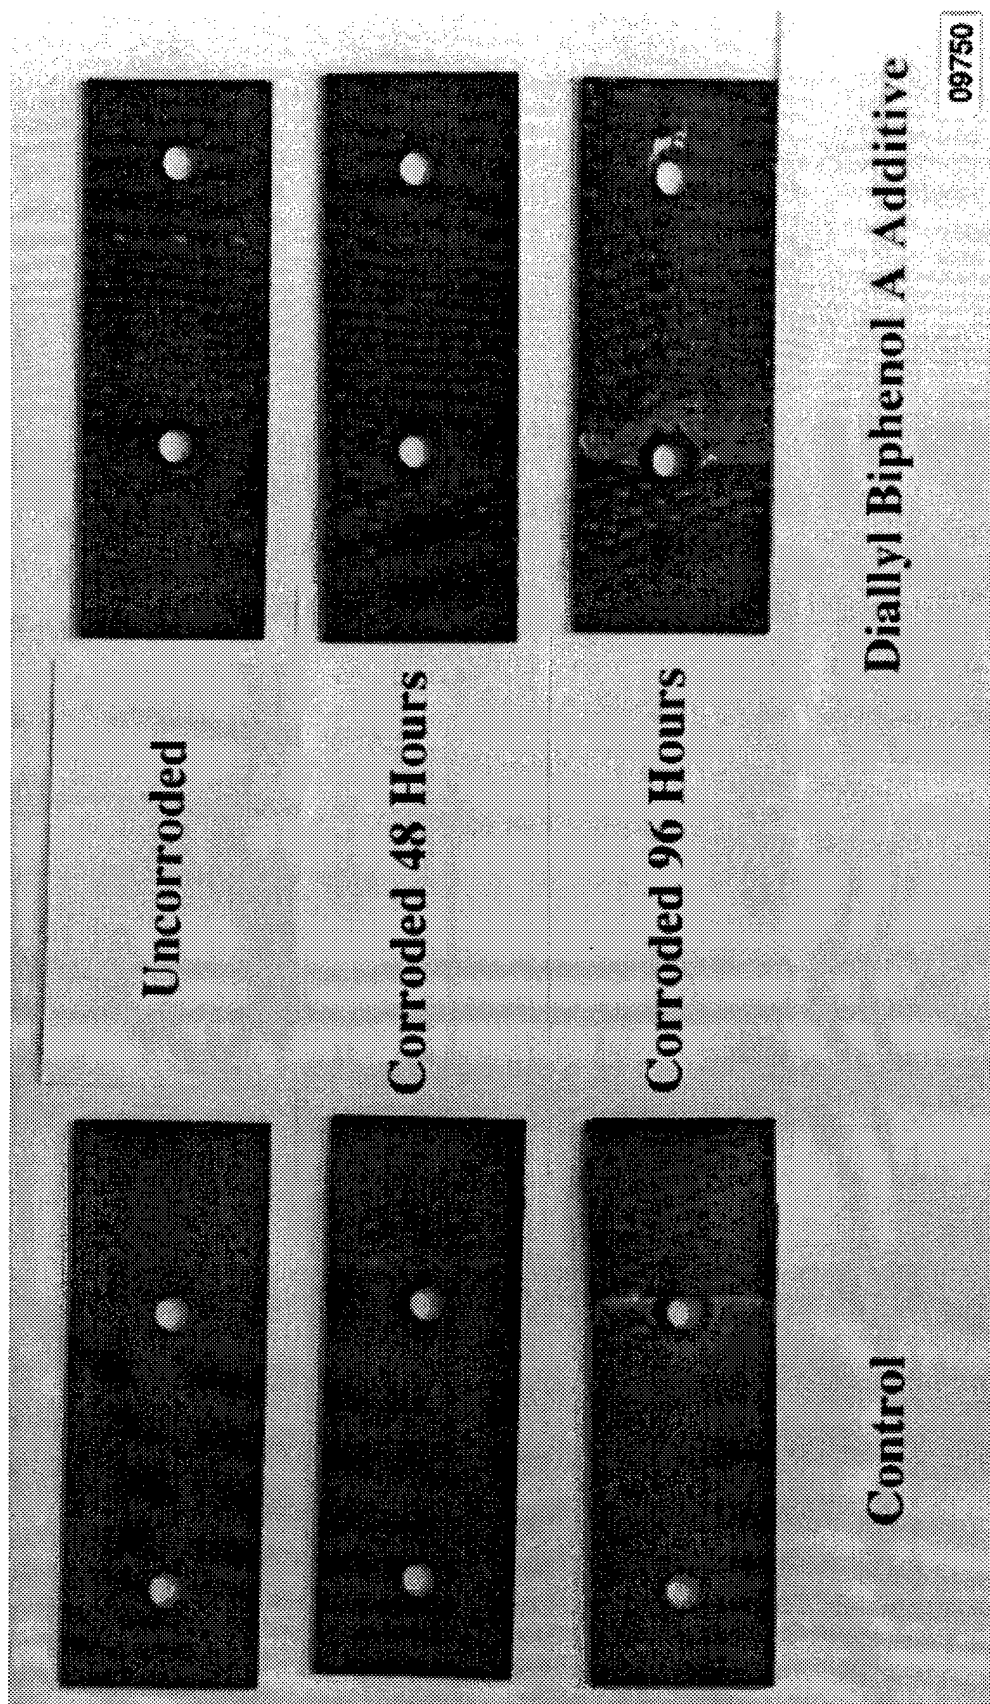
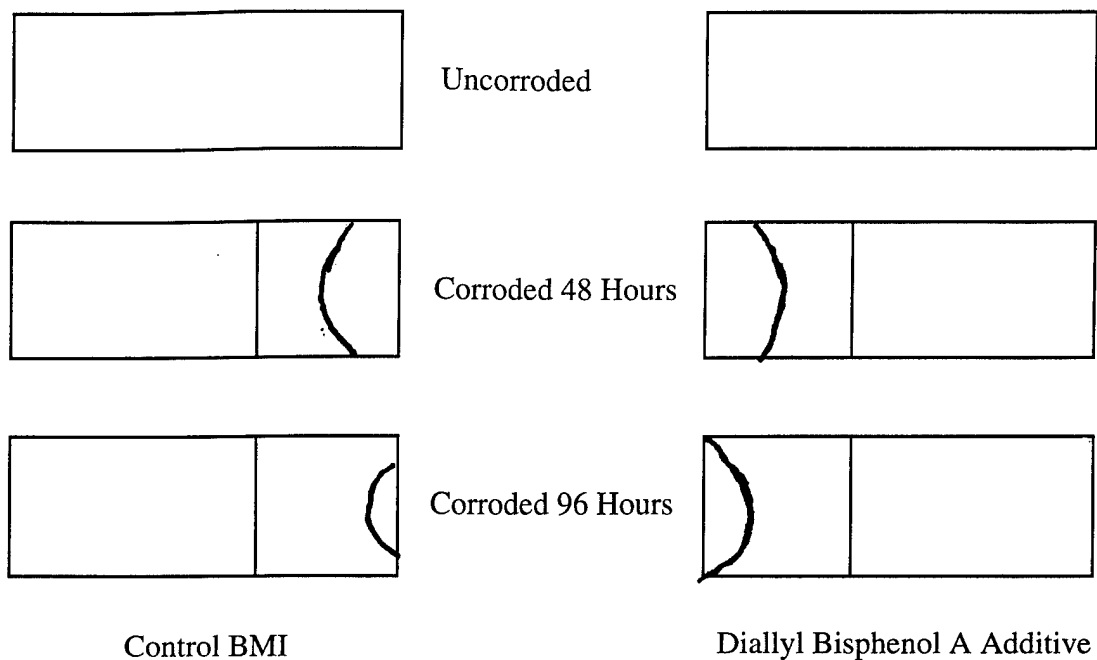
**Figure 11a.** Photos of BMI control and Matrimid samples which were uncorroded, corroded for 48 hr, and corroded for 96 hr

**Figure 11b. Illustration of the size of the corroded region for samples in Figure 11a**

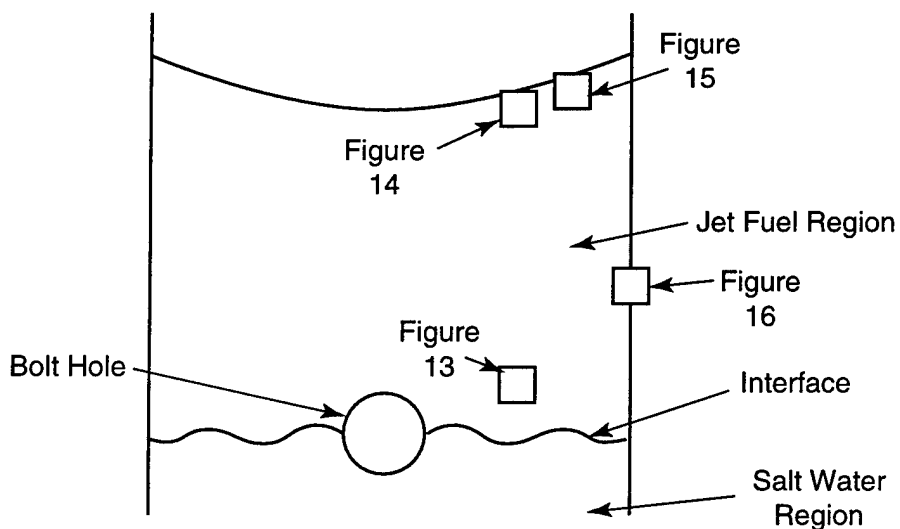
315-NAV-95123-2

**Figure 12. Locations on samples from which optical micrographs were taken**

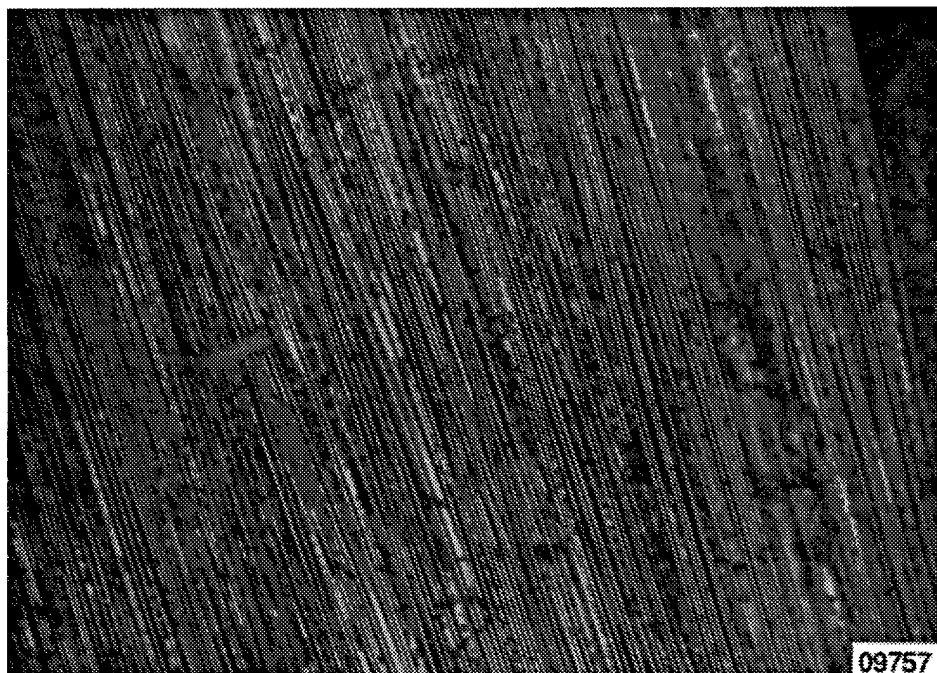
**Figure 13. Bare fibers in the center of the corrosion region in the Matrimid sample corroded for 48 hr**

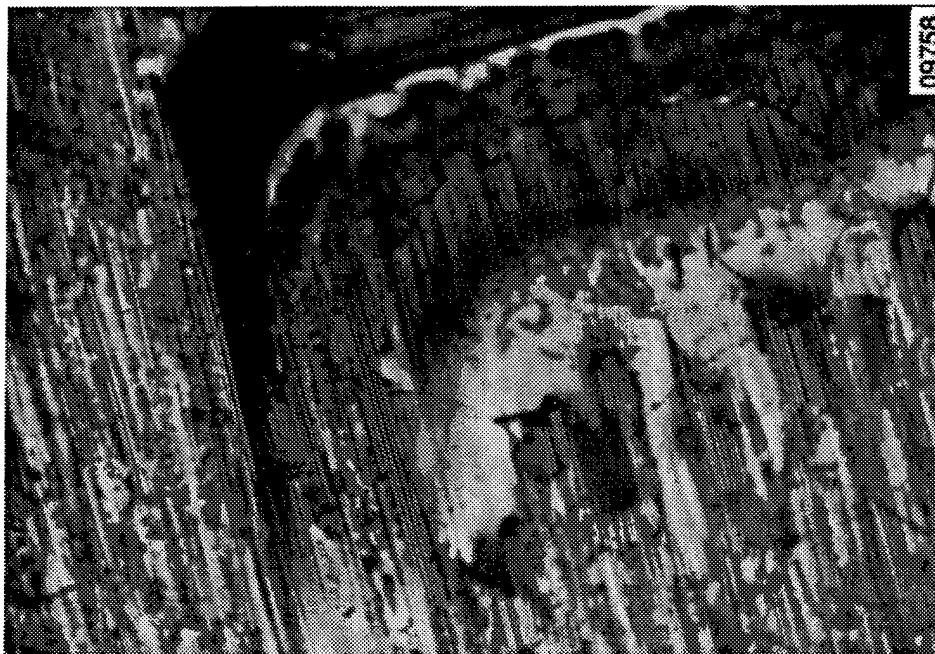
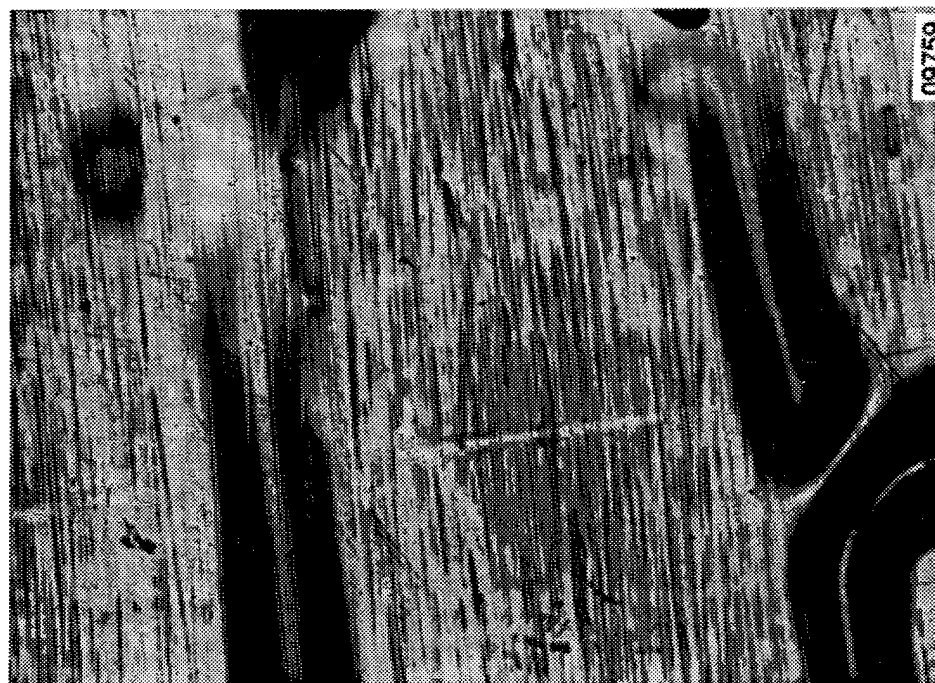
**Figure 14a.** A view of microcracking in a thick region of resin near the corrosion front of the Matrimid sample corroded for 48 hr

**Figure 14b.** A view of the uncorroded BMI control sample showing a region of the sample similar to that in Figure 14a

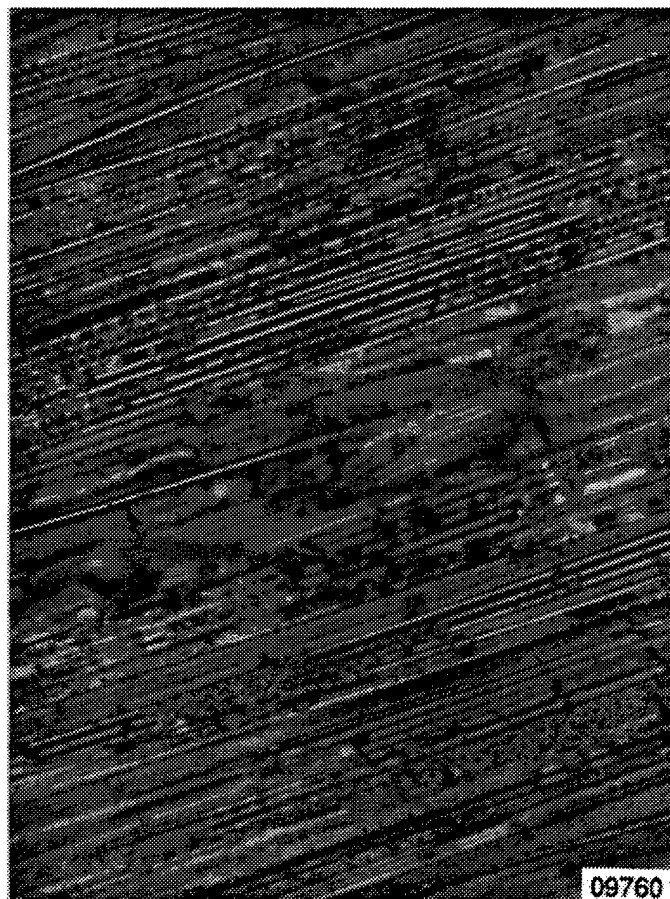
Following microcracking, the resin appears to flake off of the composite surface, rather than etching away. This is seen in Figure 15, where strips of resin are seen peeling away from the surface. This implies that after initiating microcracks, corrosion progresses locally along the fiber-matrix interface. By this mechanism, the crack tunnels beneath the resin surface, causing relatively large fragments of uncorroded resin to be removed from the surface of the composite.

**Figure 15.** *Fragments of resin peeling away from the composite surface in the 48 hr corroded BMI control sample*

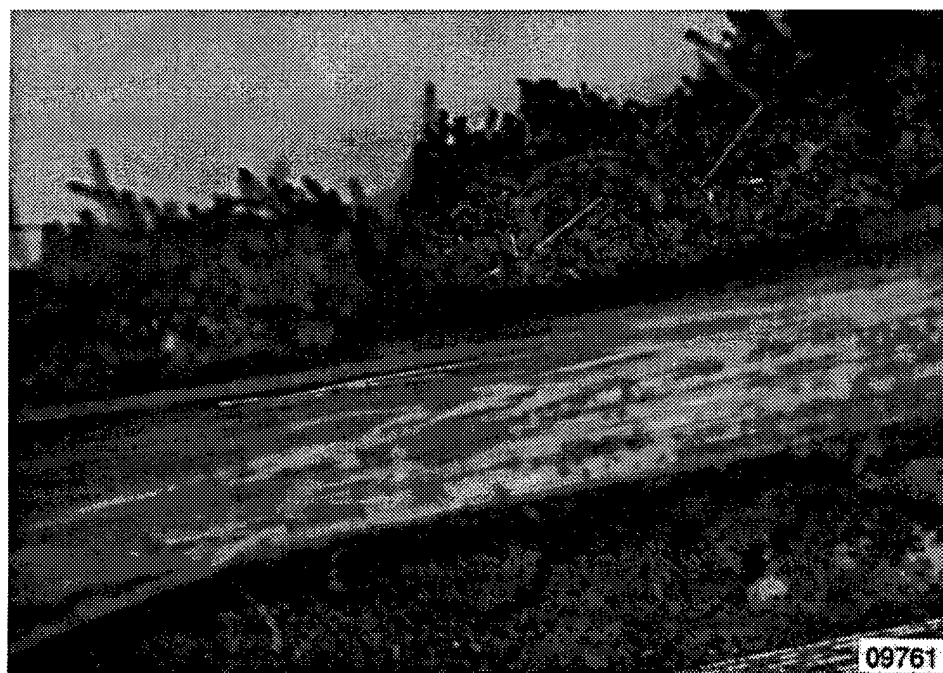
A view of the edge of the control sample corroded for 48 hr is shown in Figure 16. On the outermost ply (in the surface corrosion region), loose fibers are seen. Deeper into the sample, few loose fibers are visible. Instead, delamination occurs across the thickness of the exposed edge, although it is difficult to determine the depth to which these delaminations propagate. The mechanism of delamination is not as clear as the mechanism of resin removal on the corroding surface, although it is likely that stress corrosion cracking is involved.

**Figure 16.** *An edge view of the BMI control sample corroded for 48 hr*

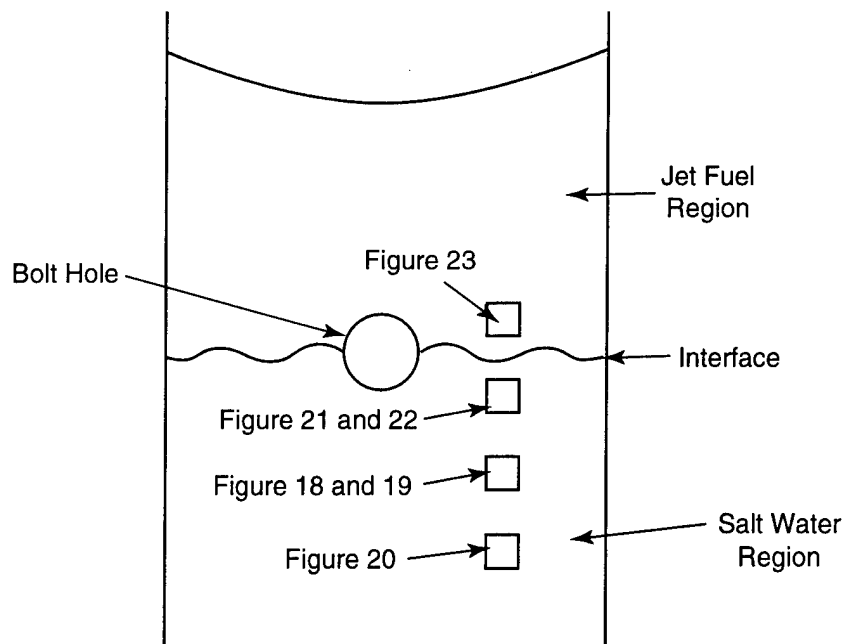
315-NAV-95123-3

SEM microscopy was conducted to verify optical microscopy observations. Since optical microscopy had indicated that all samples showed similar mechanisms of corrosion, only two experimental groups, the control and the Matrimid samples, were investigated. Uncorroded samples, as well as samples corroded for 48 and 96 hr, were examined. While most of the optical micrographs were taken in the highly corroded region above the saltwater-jet fuel interface, SEM examination indicated that similar features were present both at the corrosion front (above the saltwater-jet fuel interface) and below the interface, where the composite was exposed to the saltwater solution. Since the features below the interface were more pronounced, SEM microscopy was focused there instead of at the corrosion front. A legend showing SEM micrograph locations is shown in Figure 17.

**Figure 17. Locations on samples from which SEM micrographs were taken**
